### MARYLAND HISTORICAL TRUST DETERMINATION OF ELIGIBILITY FORM

Property Name: Smith-Remsburg Farmstead; "Neighbors Content" Inventory Number: F-4-89 Address: 7423 Marker Road City: Middletown Zip Code: 21769 USGS Topographic Map: Middletown Frederick County: Is the property being evaluated a district? yes Owner: Randy D. & Karen B. Sowers Tax Map Number: 64 Tax Account ID Number: 03-126048 Tax Parcel Number: 132 Agency: Maryland Dept. of Budget and Mgmt. Project: DBM-0475-Lamb's Knoll DOE Site visit by MHT staff: X no \_\_\_\_yes Name: Date: Is the property is located within a historic district? yes X no If the property is within a district District Inventory Number: NR-listed district \_\_\_\_\_ yes Eligible district \_\_\_\_\_ yes Name of District: \_\_\_\_\_ Preparer's Recommendation: Contributing resource yes no Non-contributing but eligible in another context yes If the property is not within a district (or the property is a district) Preparer's Recommendation: Eligible X yes \_\_\_\_\_\_no A B X C D Considerations: A B C D E F G None Documentation on the property/district is presented in: Project File Description of Property and Eligibility Determination: (Use continuation

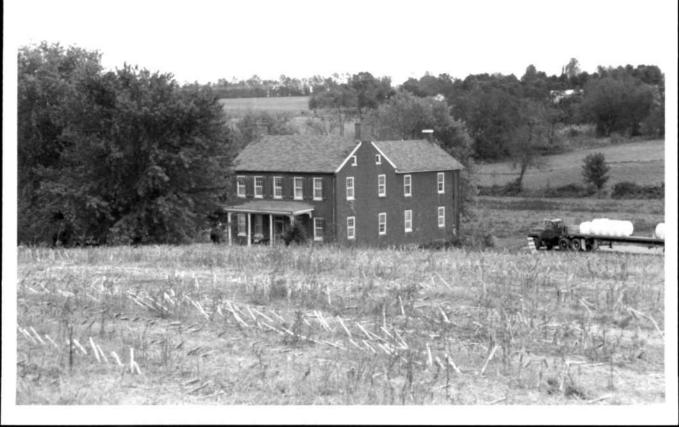
10f3

F-4-89 Smith-Remsburg Farmstead, 7423 Marker Road Frederick County, MD EHT Traceries 10/2003 MD SHPO

nouse, looking west

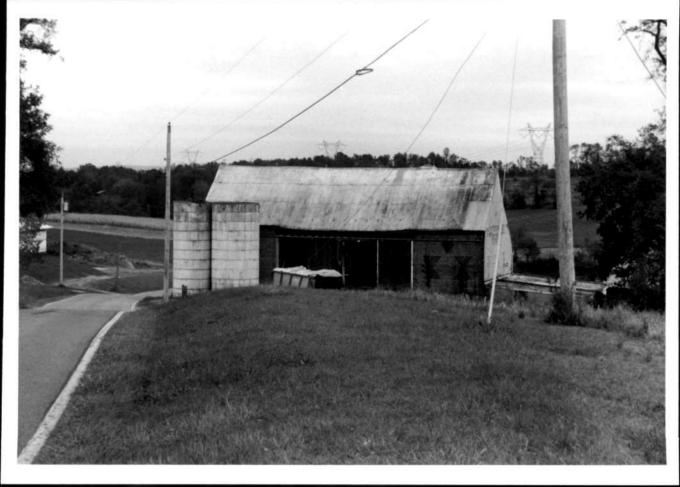
of3

F-4-89 Smith-Remsburg Farmsfead, 7423 Marker Road Frederick County, MD EHT Traceries 10/2003 MD SHPO

barn, looking southwest

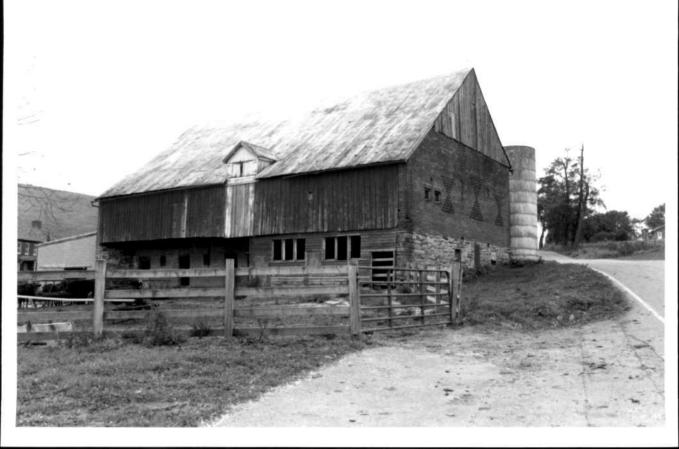
3.F3

F-4-89 Smith - Remsburg Farmstead, 7423 Marker Road Frederick county, MD EHT Traceries 10/2003 MD SHOO barn, looking northeast

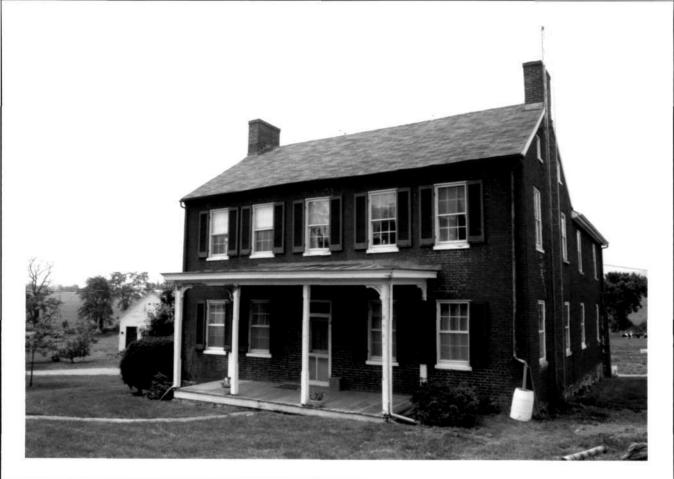
F-4-89 Smith-Remsburg Formstead Frederick County Photo: Janet Dovis June 1992 Neg. loc.: Md. SHPO, Crownsville, Md. Northeast corner view

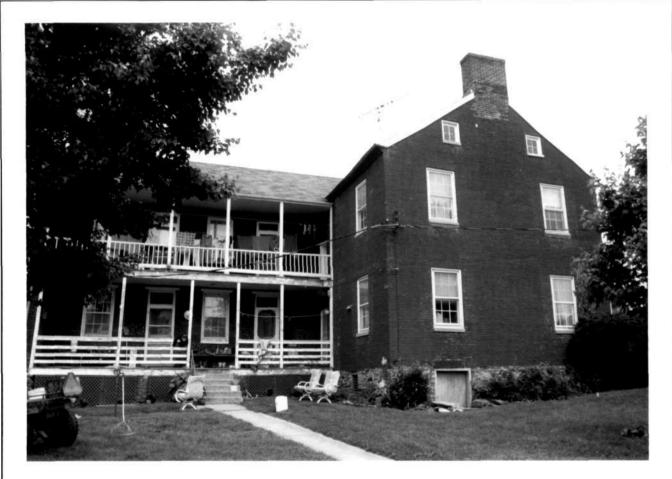
F-4-89 Smith-Remsburg Formstead Frederick County Photo: Janet Davis June 1992 Neg. loc.: Md. SHPO, Crownsville, Md. South elevation

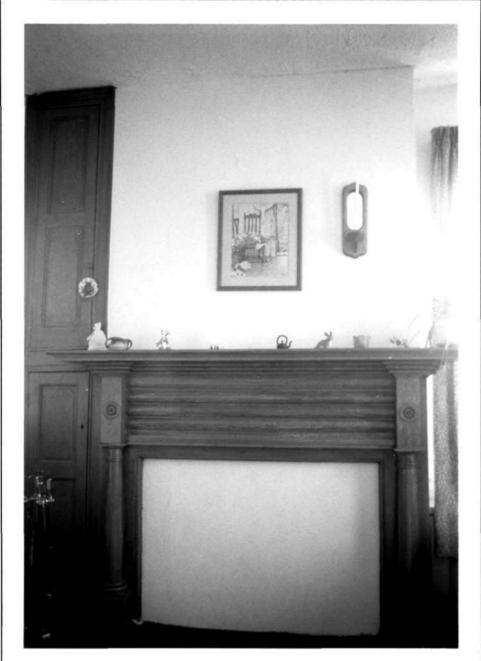
F-4-89 Smith-Remsburg Farmstead Frederick County Proto: Janet Dovis June 1992 Neg. loc.: Md. SHPO, Crownsville, Md. 1101th portor montel

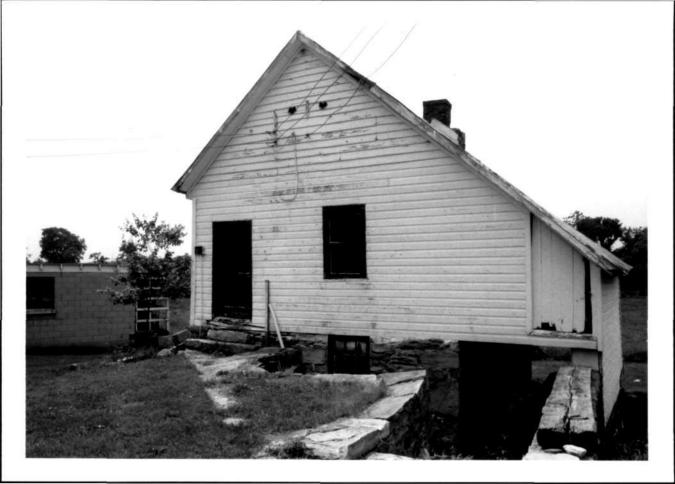
Springhouse: The springhouse has a stone lower level and a log upper section covered with german siding except in the north gable where beaded clapboards, probably the original siding, is intact. At the northwest corner of the stone section is a stone inscribed with a panel surrounding the initials "H S" flanking heart above the date 1812. The heart motif is repeated in the gable of the log section as a vent opening. "H S" is undoubtedly Henry Smith, who was the owner

F-4-89 Smith-Remsburg Formstead Frederick County Photo: Janet Davis June 1992 Neg. loc. Md. SHPO, Crownsville, Md. Springhouse, north elevation

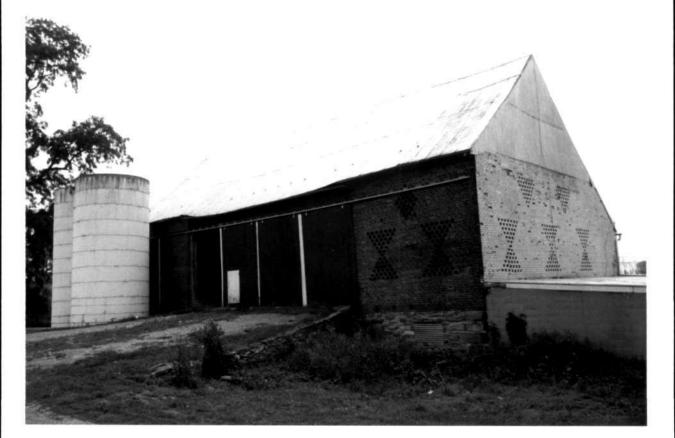
Bank barn and milk house: The large brick and frame bank barn was probably built between 1825 and 1850. The brick end walls in 5:1 American bond have vents in the shape of wheat sheaves or hour glasses. On the north elevation are sliding tongue-and-groove doors, which replace the probable original swing The roof is corrugated metal over wood shingles. Next to the ramp on the north side is the concrete base of a silo which has been removed. On the south elevation, the stall level is walled with brick. On the east end is a frame enclosure sided with german siding, the original milking room, an alteration of the first quarter of the 20th century. On the west end of the barn is a concrete block tractor shed, a later 20th century addition. The vertical sided forebay above the stall level has a loading door below a projecting dormer in the approximate center of the elevation. Adjacent to the east end of the barn and at the edge of Marker Road is a one-story concrete block milk house built in the first quarter of the 20th century. It has a standing seam metal roof and metal casement windows.

F-4-89 Smith-Remsburg Formstead Frederick County Photo: Janet Davis June 1992 Neg. loc.: Md. SHPO, Crownsville, Md. Bonk born, north elevation 5/7

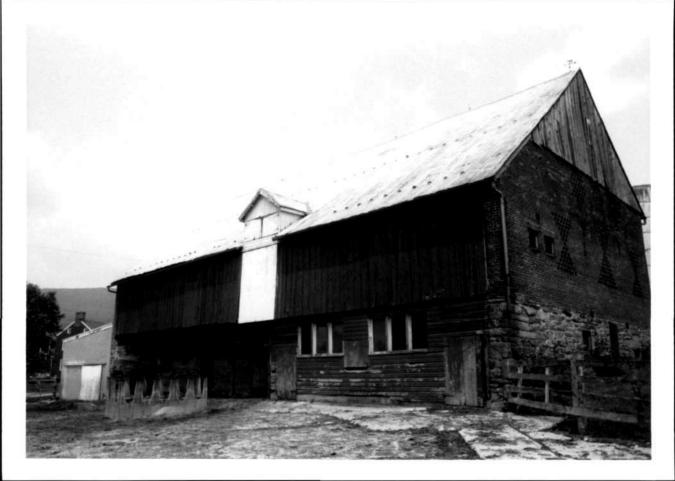
F-4-89 Smith-Remsburg Formstead Frederick County Photo: Jonet Davis June 1992 Neg. loc.: Md. SHPO, Crownsville, Md. Bank Darn, South elevation 6/7

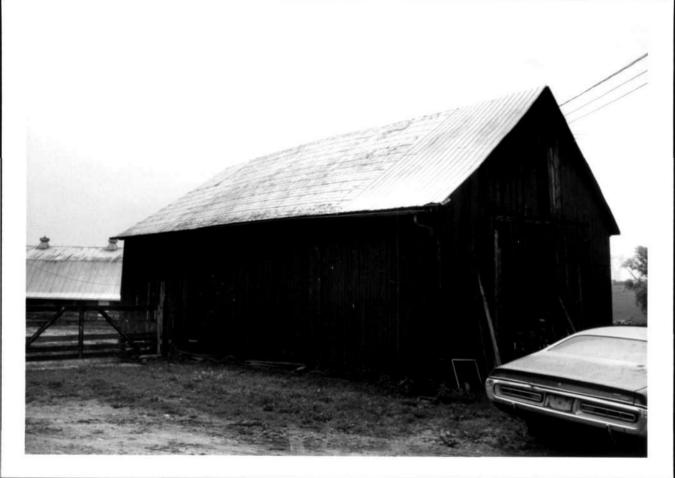
Wagon shed/corn crib: The frame wagon shed with corn cribs was built in the last quarter of the 19th century. It has vertical siding and sliding doors on the north elevation with a roof covered in both pressed metal and standing seam metal.

F-4-89 Smith-Remsburg Formstead Frederick County Photo: Janet Davis June 1992 Neg. loc.: Md. SHPO, Crownsville, Md. Wagon shed, northwest corner view 7/7
